# **PFAS in North Kent County**

## **House Street PFAS Plumes & Geology**

**Wolverine CAG- December 19, 2019**

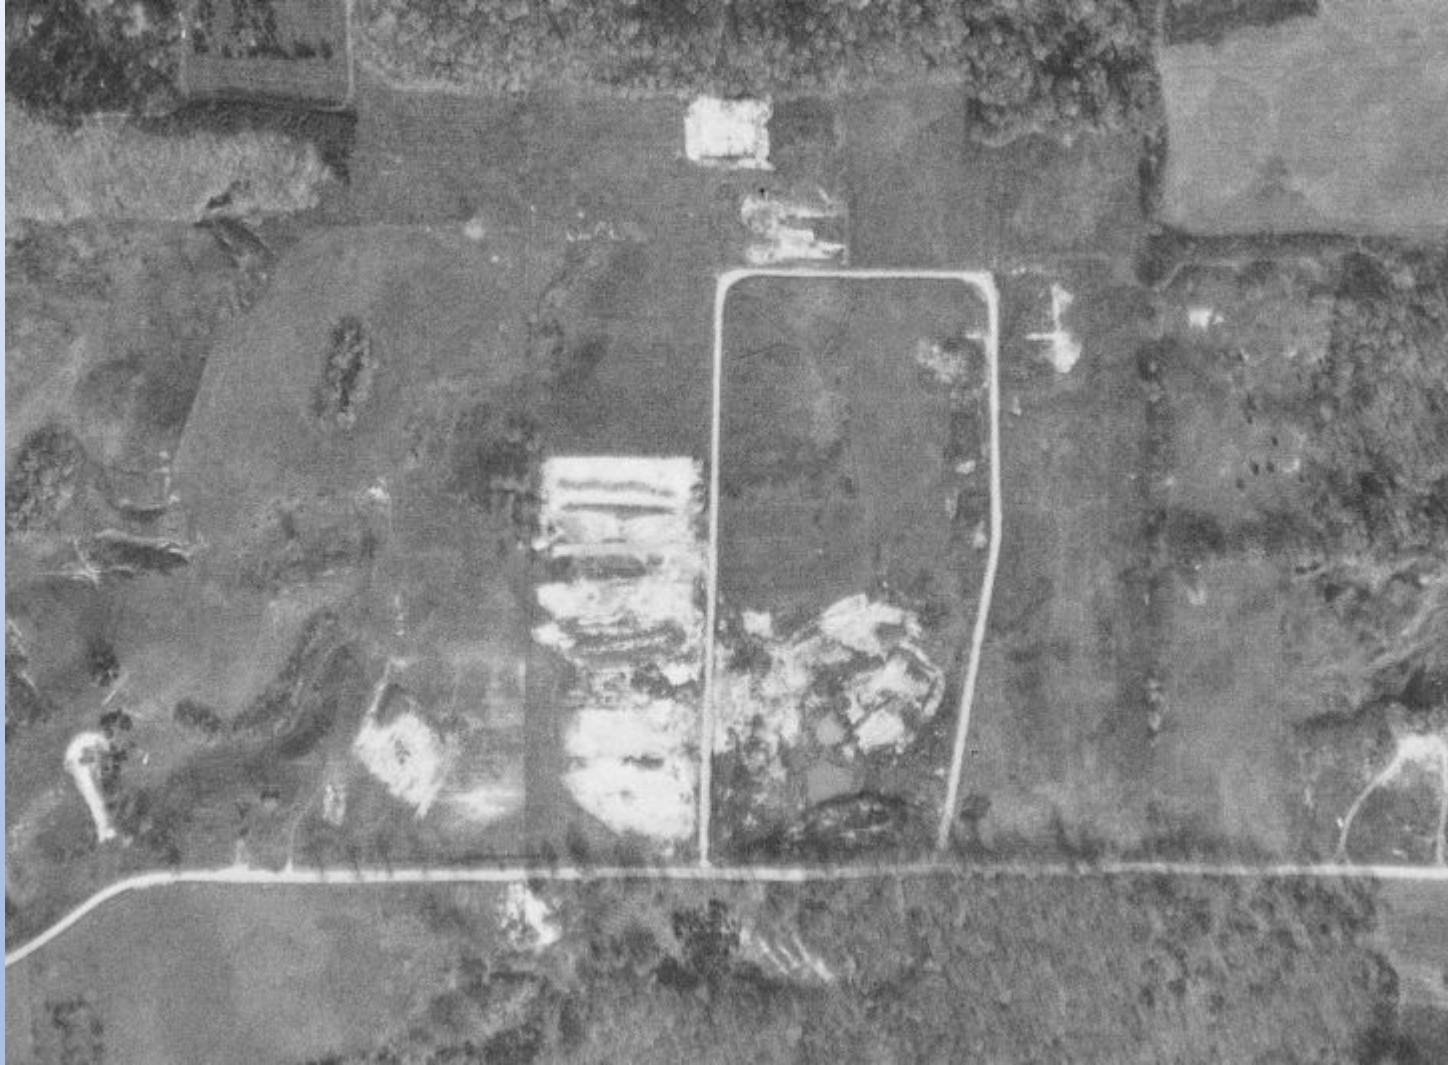
1965 USGS

Waste materials disposed of in unlined trenches, ponds, lagoons and into lowlands/ravines

- Early 1940s - Disposal by WWWW started on House Street
- 1964 - WWWW purchases the property
- 1966 – Site becomes licensed disposal facility
- 1970 – Site ceases to be in active use as disposal site
- 1978 – License as solid waste disposal area surrendered
- 2018 – Drilling for EPA indicates at least 30-40 acres of was

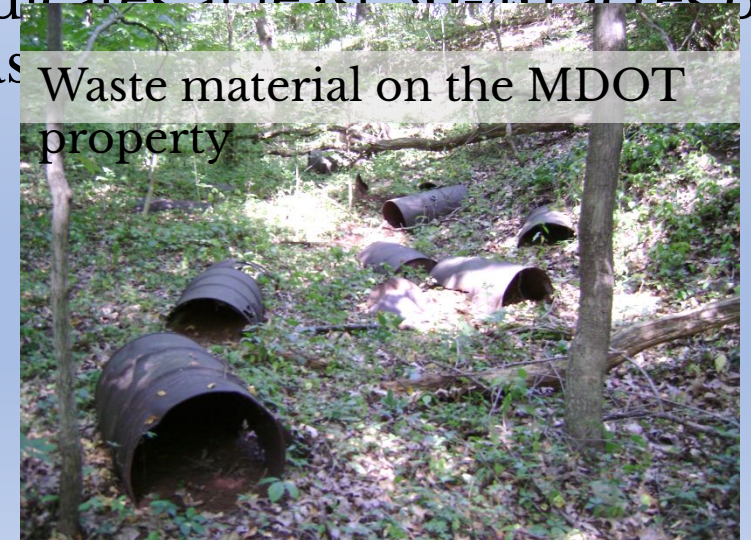
Waste material on the MDOT property

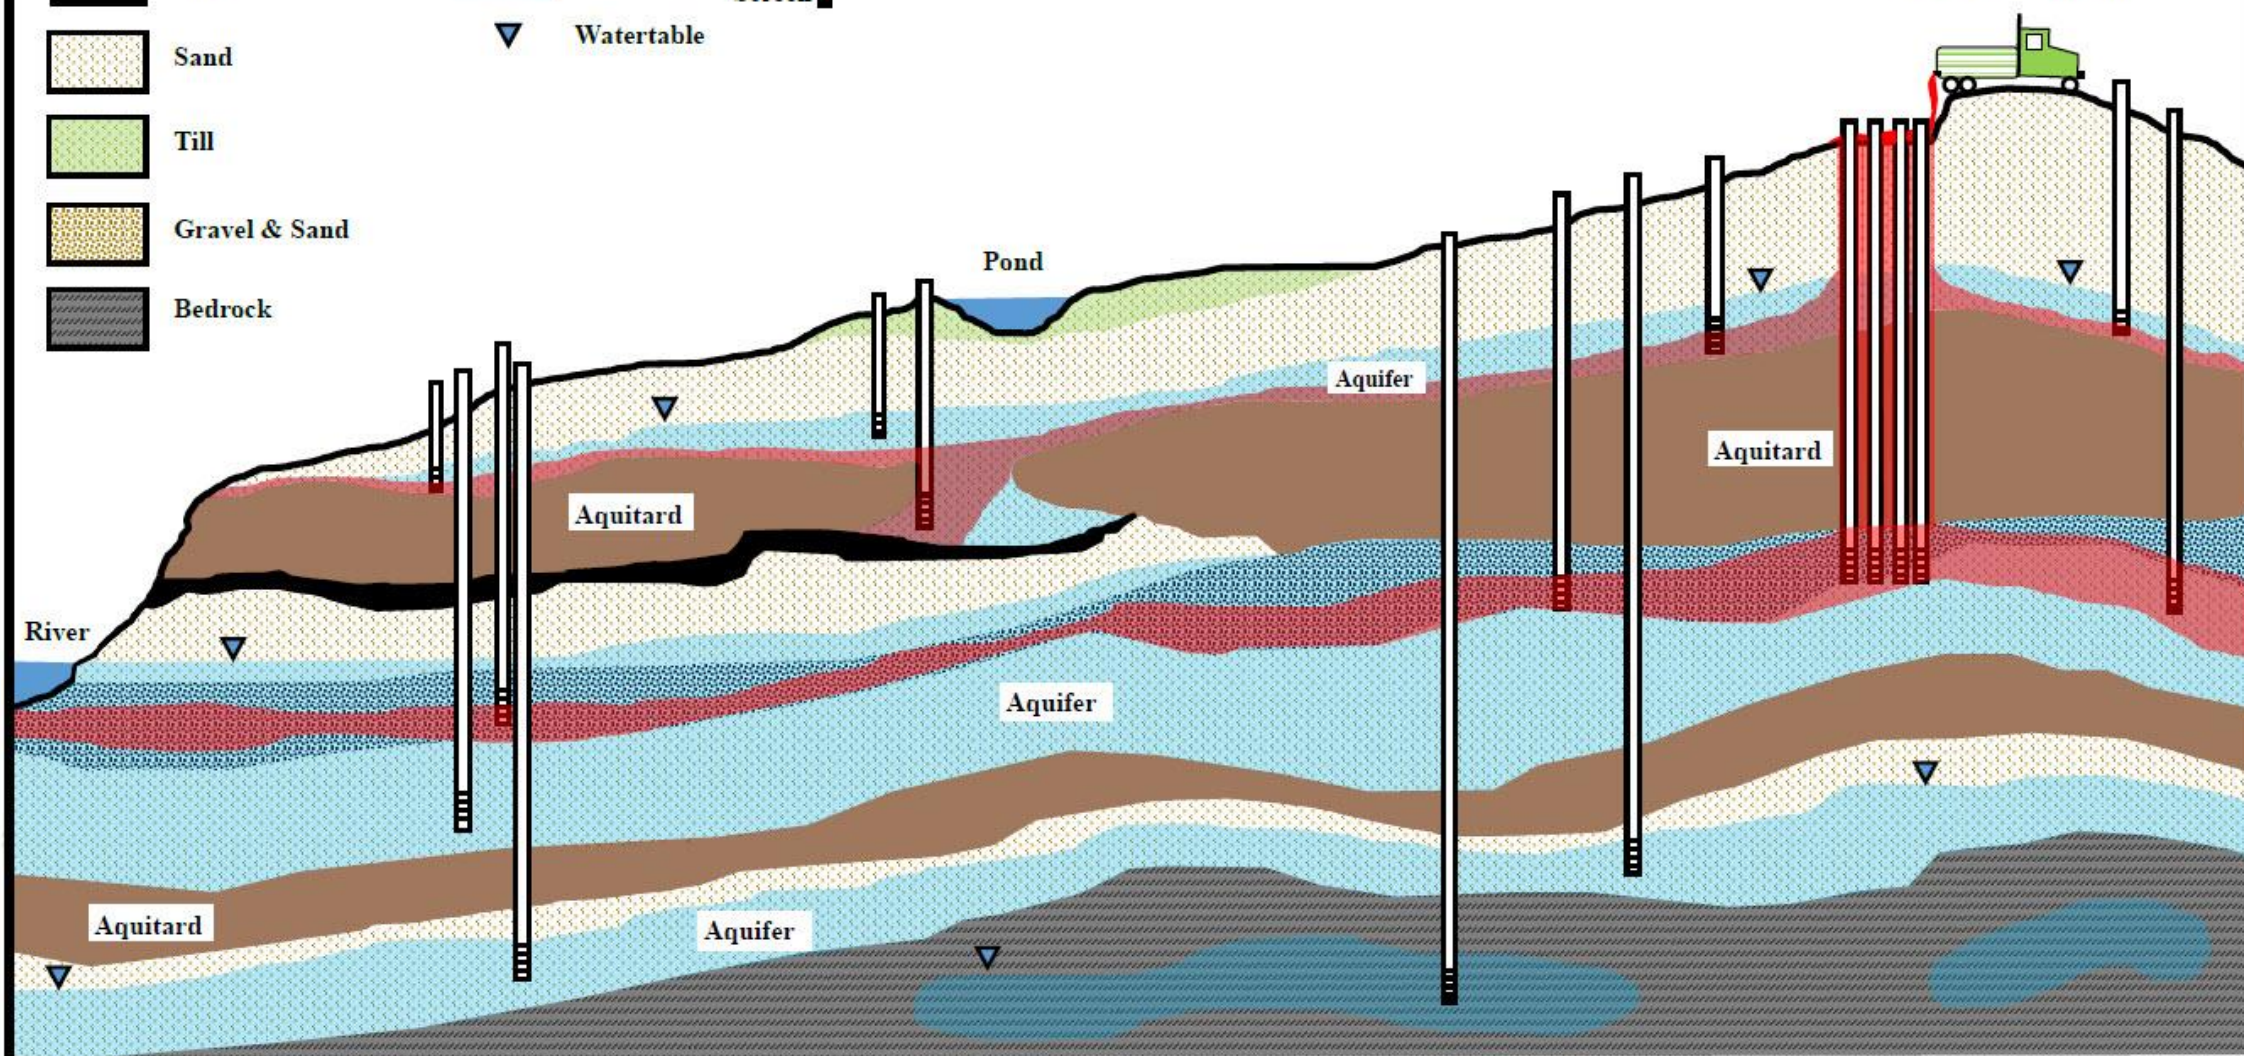
Source Area from Historical  
Surficial Dumping

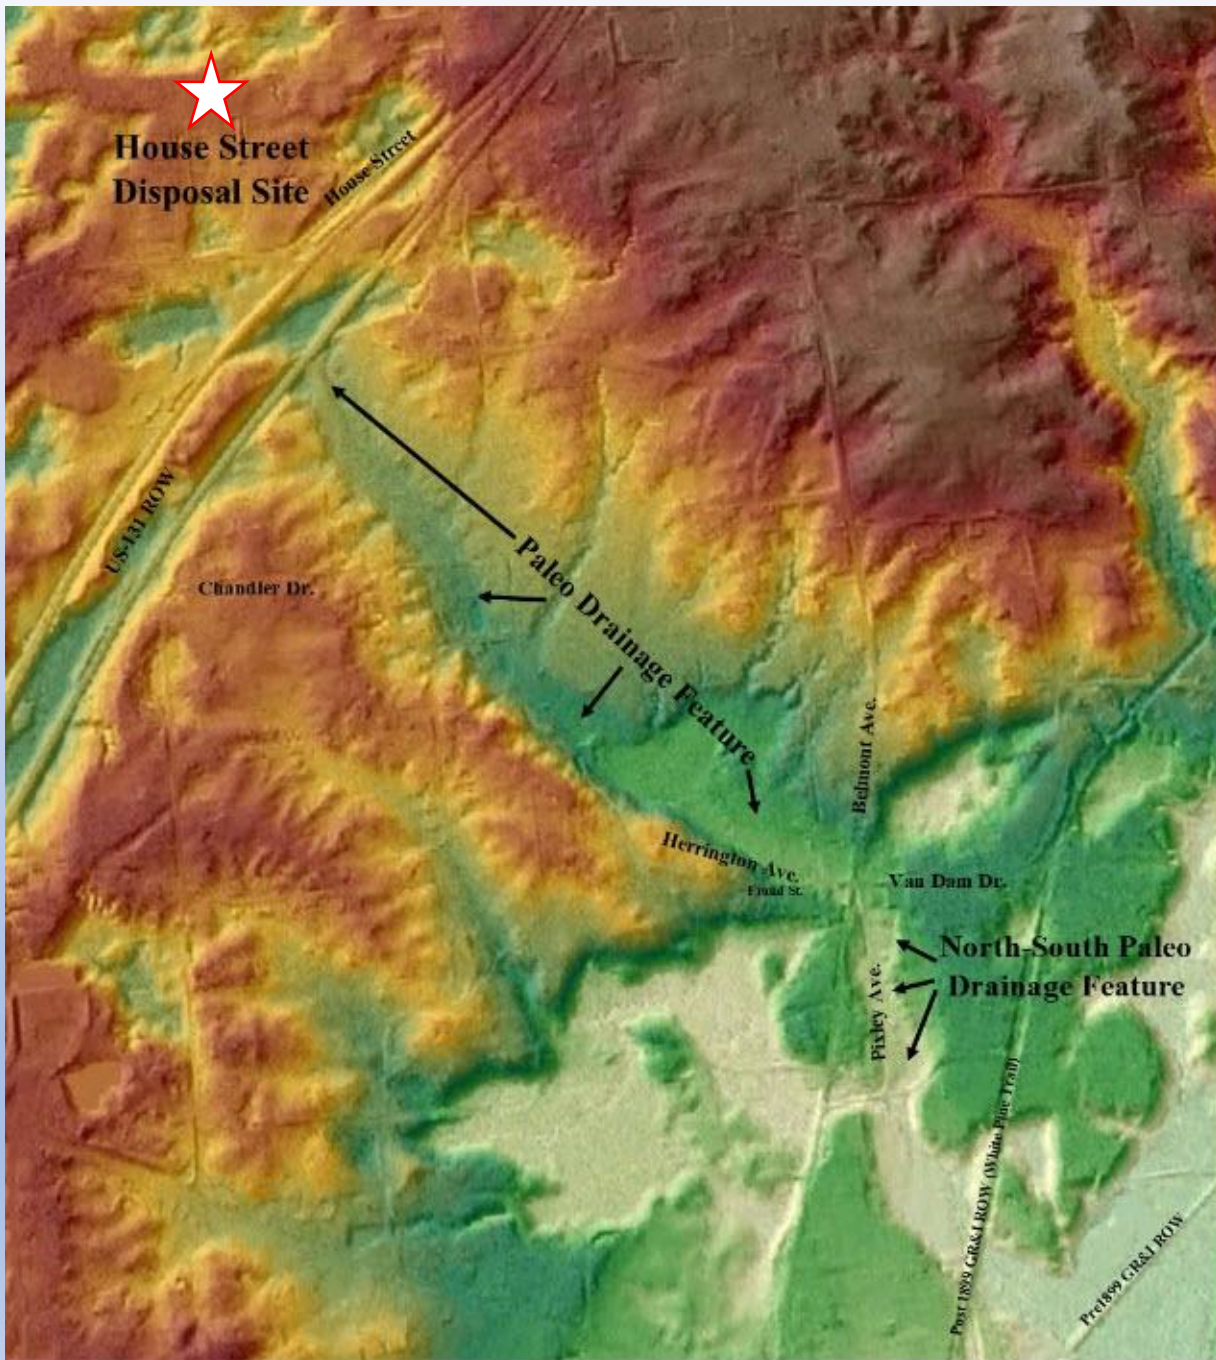
- Drinking Water wells over 70ppt PFOA/PFOS: 39
- Drinking Water wells over 1,000 ppt for PFOA/PFOS: 5
- Drinking Water well's highest concentration: 96,000 ppt
- On groundwater divide with flow in multiple directions; Rogue River encircles area
- Basic House Street Disposal Area geology: surficial clay underlain by sand to 175'; depth to first impacted aquifer approximately 60'

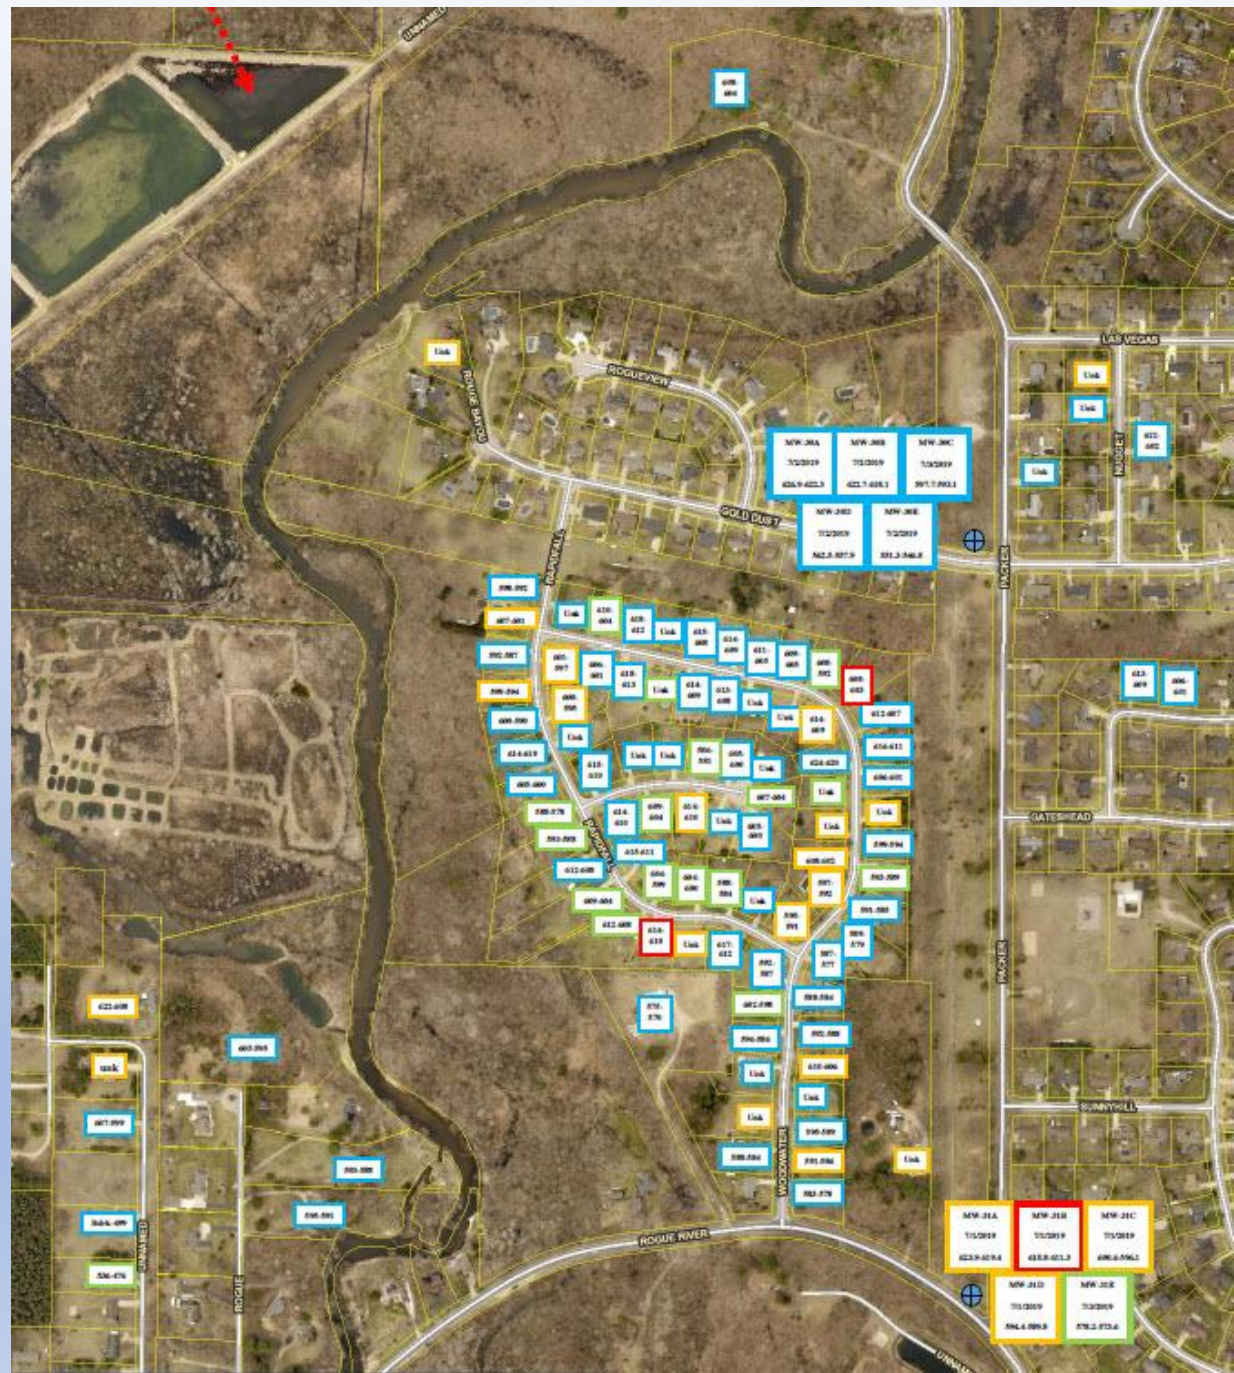
- Lack of monitor wells hinders plume definition closer to the river

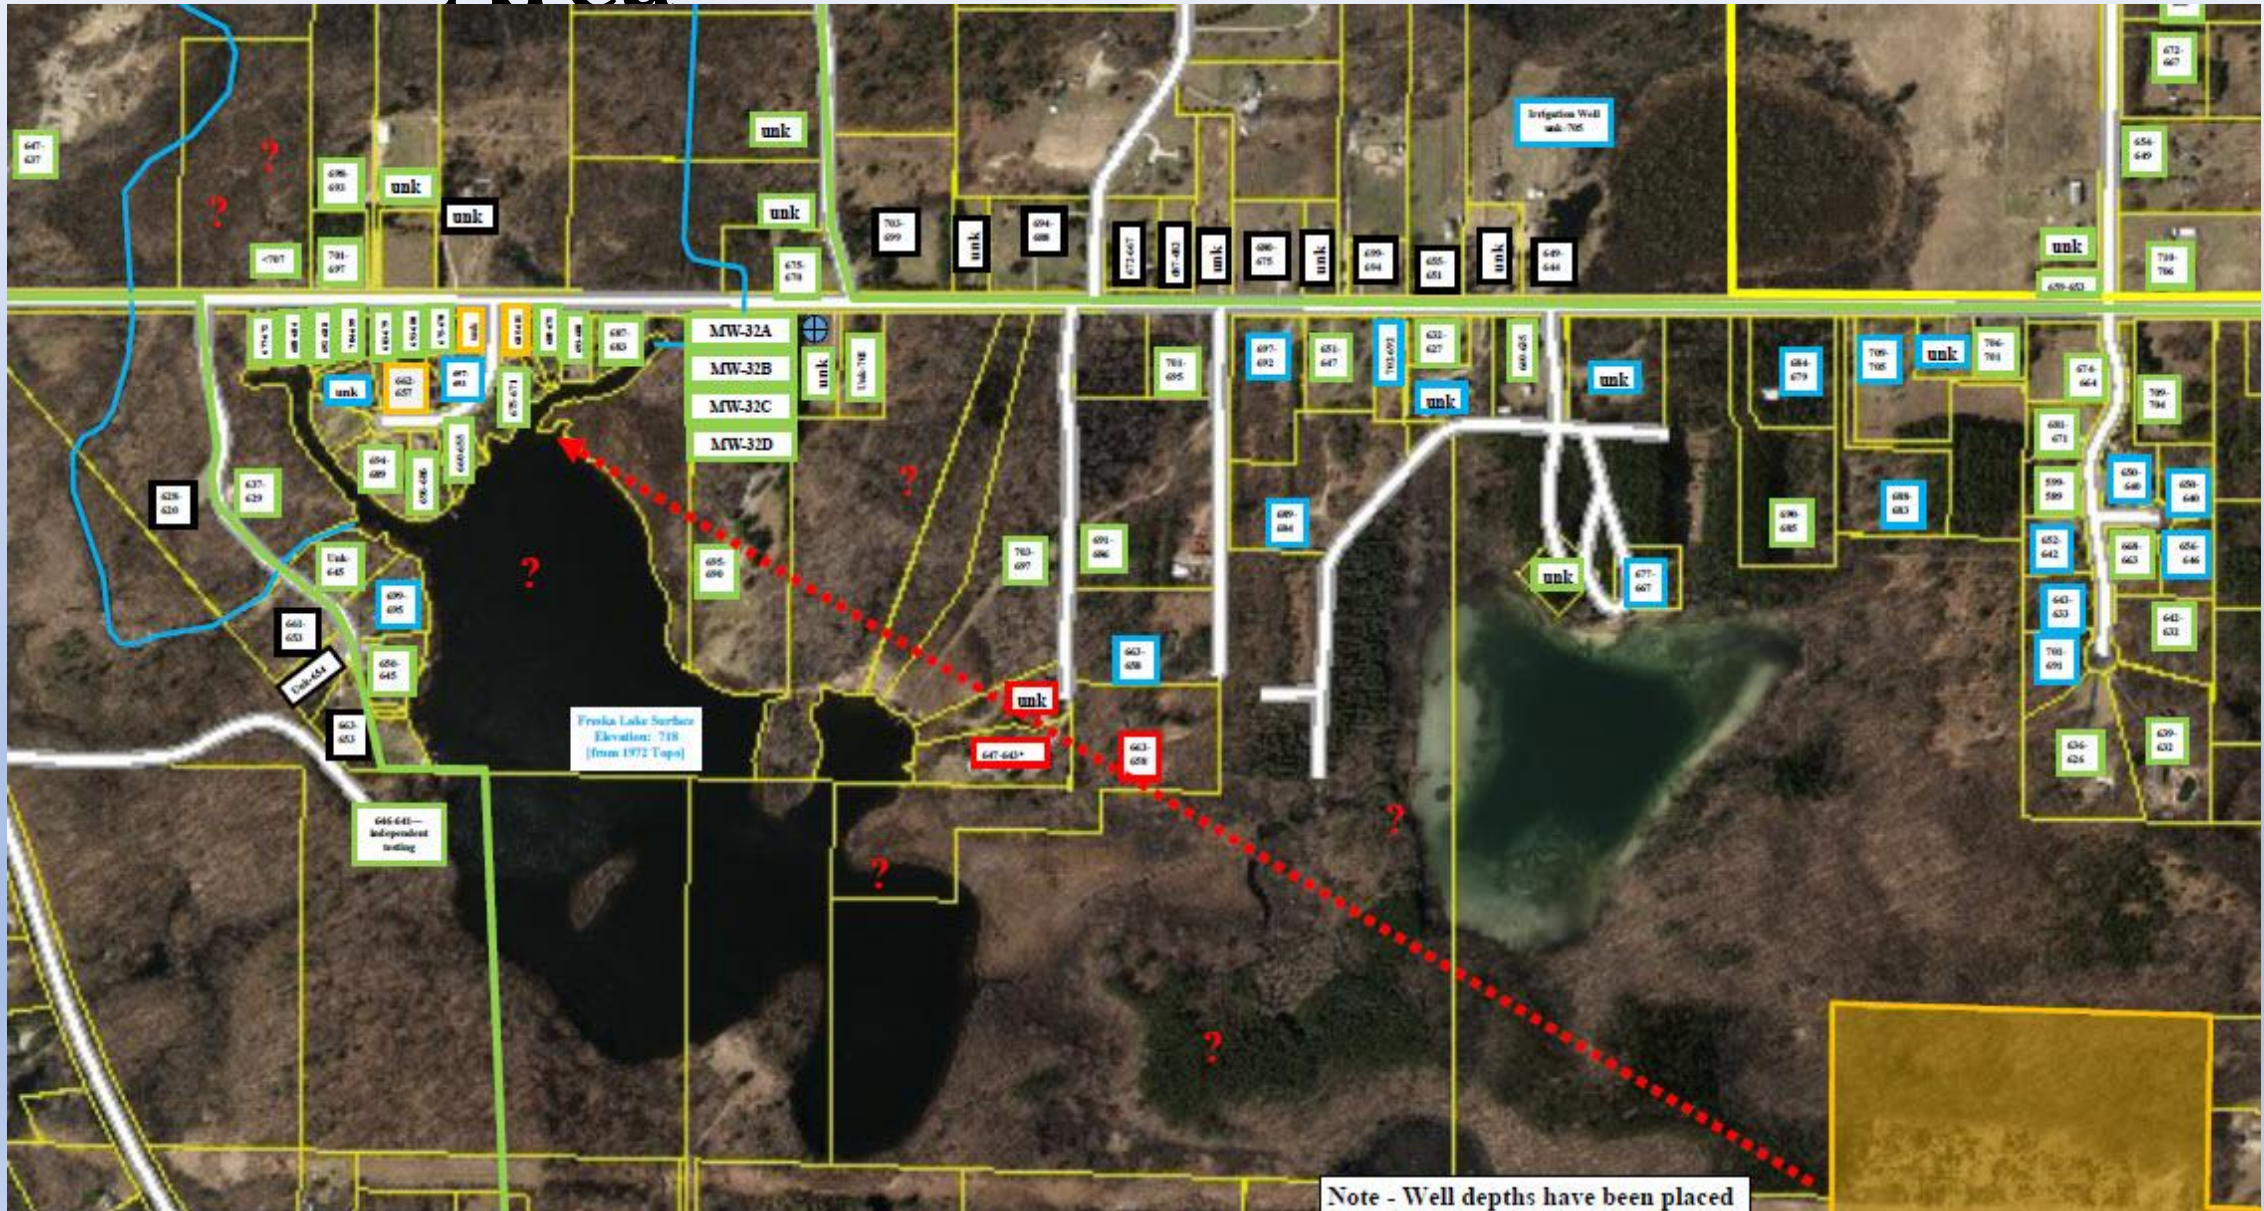
- Plume to the northwest is not delineated
